Audi > A4, S4 > 1996-2001**1.8 Liter 4-Cyl. 5V Turbo Generic Scan Tool Engine Code(s): AEB
28 - Ignition, Servicing**

Camshaft Position Sensor, Checking**Note:**

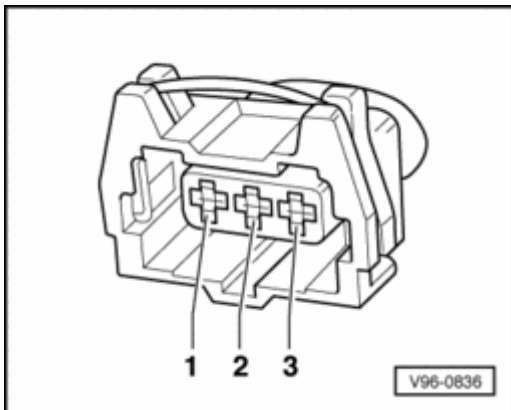
- Using a Multimeter , Check the Camshaft Position (CMP) Sensor G40 electrical harness connector terminals 1 to 3 for voltage.

Specified value: at least 4.5 V
