REPAIR OF LCM ON A E39 –1997

Symptoms

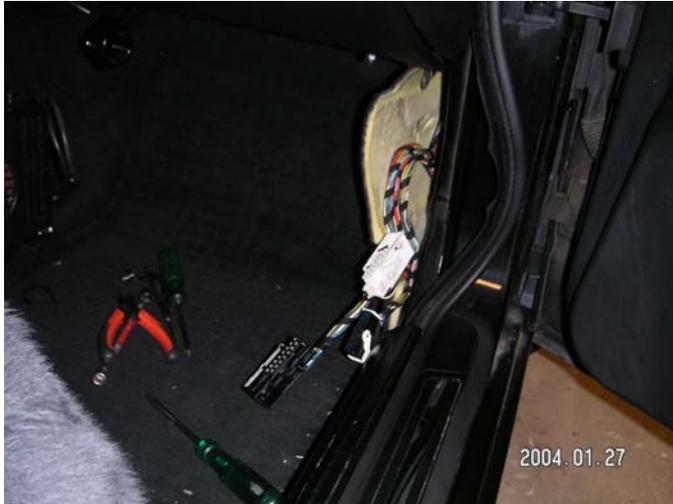
Picture 1.
LCM is located on the right side on a LHD car
You see the 3 connectors to the LCM.

- 1) Disconnect the battery cables
- 2) You will locate the LCM under the right trim panel picture 1.
- 3) You need an 8mm tool to unscrew the LCM
- 4) Disconnect the 3 connectors on the LCM.
- 5) Open up the LCM.
- 6) Open the tension clips which hold the transistors against the cooling flange.
- 7) Unscrew the cooling flange
- 8) Remove the cooling flange carefully from the effect transistors.
- 9) The transistor is soldered on both sides.
- 10) Remove the transistor using the appropriate listed equipment with caution.
- 11) Solder in the new transistor
- 12) Replace everything as a reversal of the removal procedure.

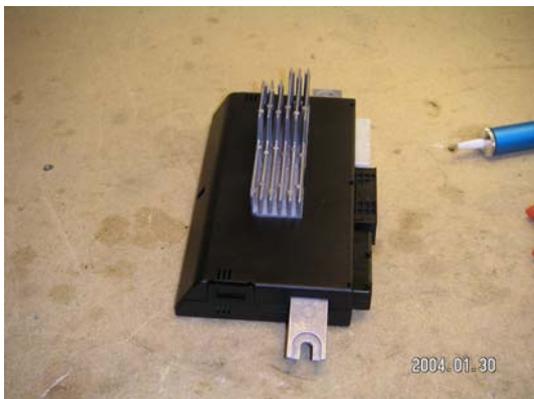
Picture 2.
Here is the LCM

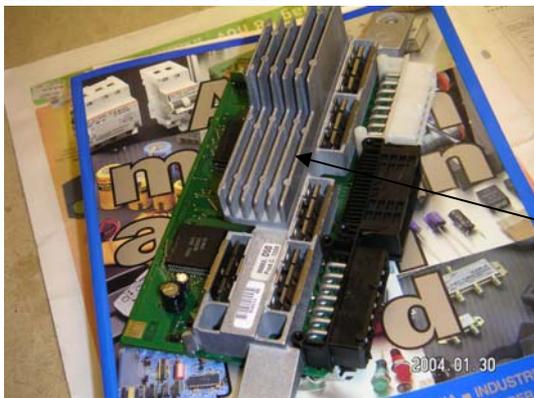
Bild 3.
Here is the cover off.

Cooling flange

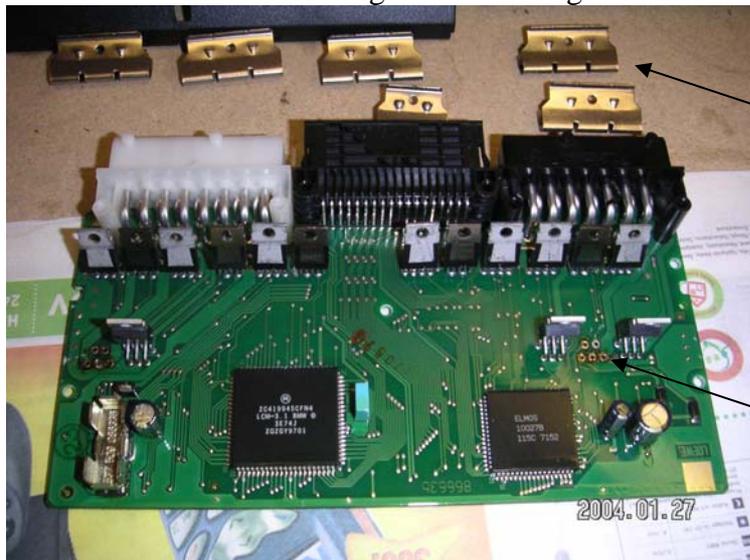
Picture 4.

Here is the tensionclips and cooling flange been taking away.

The effecttransistors fore Right and Left High beam has been unsoldered

Tensionclips.

R.Highbeam.

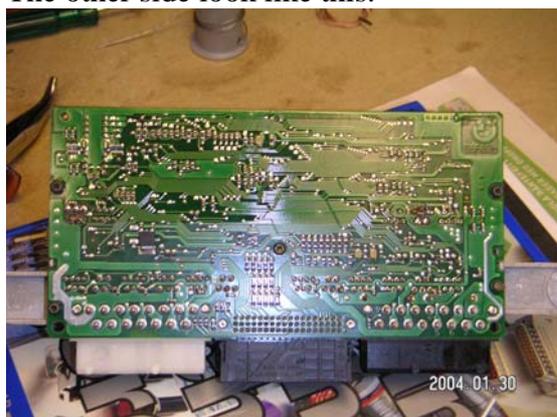
Picture 5.

The other side look like this.

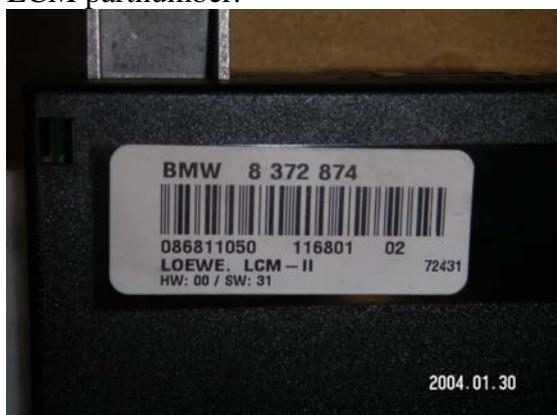
Picture 6

LCM partnumber.
